Trip Report

Project	Cedar Chemical Site
Location	Helena-West Helena
Date	4/27/2012
Time	1100 to 1136 hours
Reason	Monthly Site Visit
ADEQ personnel	Annette Cusher Jim Rigg
Facility, contractor and EPA personnel	Mr. Harrington
Activity Summary	<p>Jim and I were met upon arrival at the site by Mr. Harrington. The following issues were discussed during the walk through.</p> <ul style="list-style-type: none"> • A pole was removed cracking the asphalt while demolishing a shed. The remaining poles were cut off at the level of the asphalt. • The old lab building is collecting water after rain events and has become moldy. Harcross would like to demolish the building. • The waste from the renovation of the sump is still covered on a slab. Mr. Harrington indicated Harcross was in contact with Clean Harbors for disposal. • Mr. Harrington also indicated that Harcross would be running underground utilities when they begin to utilize the unused unit. • There are several five gallon buckets of what appears to be purge water (buckets are labeled with monitoring well numbers) still on-site. Harcross would like to know what should be done with the containers. • There is a desk and files being moved

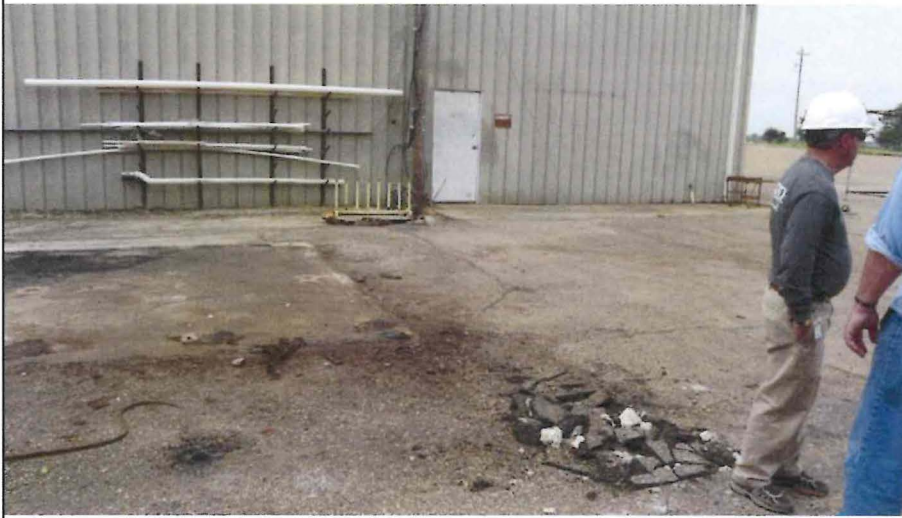
Location:		Cedar Chemical Site						
Photographer:		A. Cusher			Witness:		J. Rigg	
Photo #	1	Of	6		Date:	4/27/2012	Time:	
Description:		Cracked asphalt from pole removal

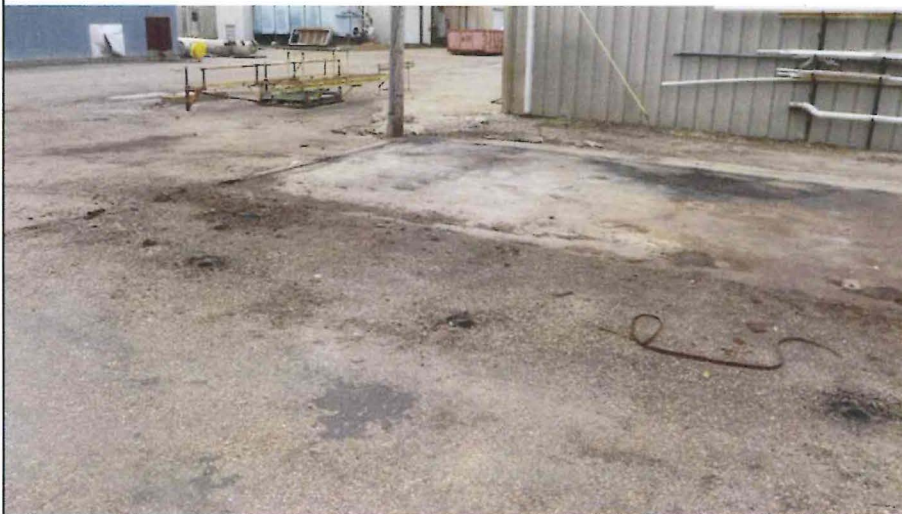
Photographer:		A. Cusher			Witness:		J. Rigg	
Photo #	2	Of	6		Date:	4/27/2012	Time:	
Description:		Area where poles were cut off at asphalt level

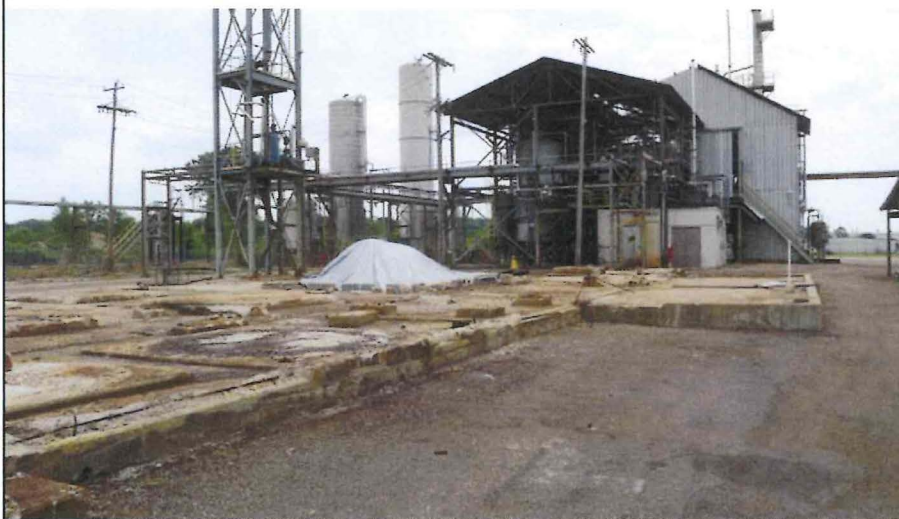
Location:		Cedar Chemical Site						
Photographer:		A. Cusher			Witness:		J. Rigg	
Photo #	3	Of	6		Date:	4/27/2012	Time:	
Description:		Covered waste pile

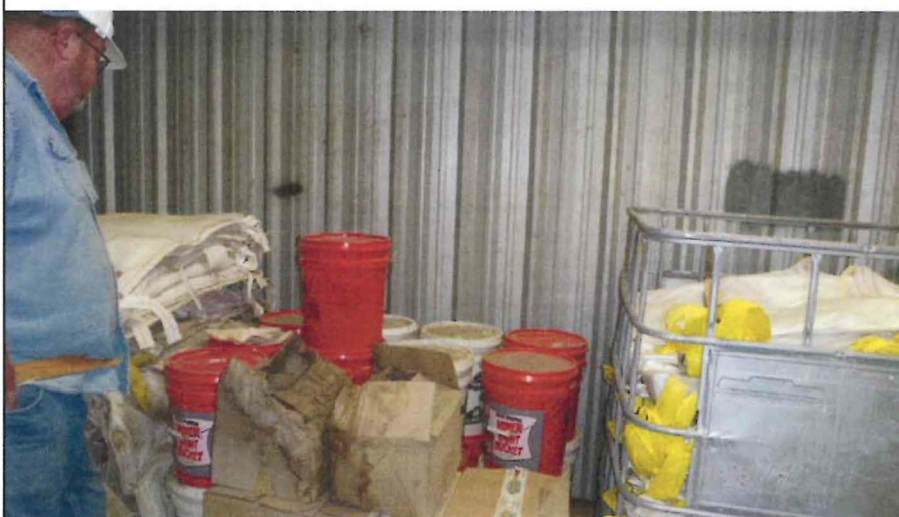
Photographer:		A. Cusher			Witness:		J. Rigg	
Photo #	4	Of	6		Date:	4/27/2012	Time:	
Description:		5 gallon containers of purge water

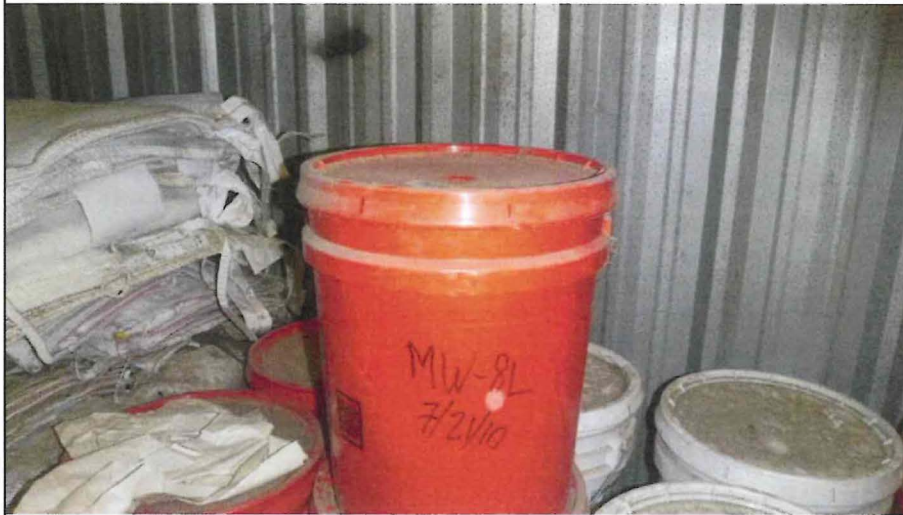
Location:		Cedar Chemical Site						
Photographer:		A. Cusher			Witness:		J. Rigg	
Photo #	5	Of	6		Date:	4/27/2012	Time:	
Description:		Close up of 5 gallon container label

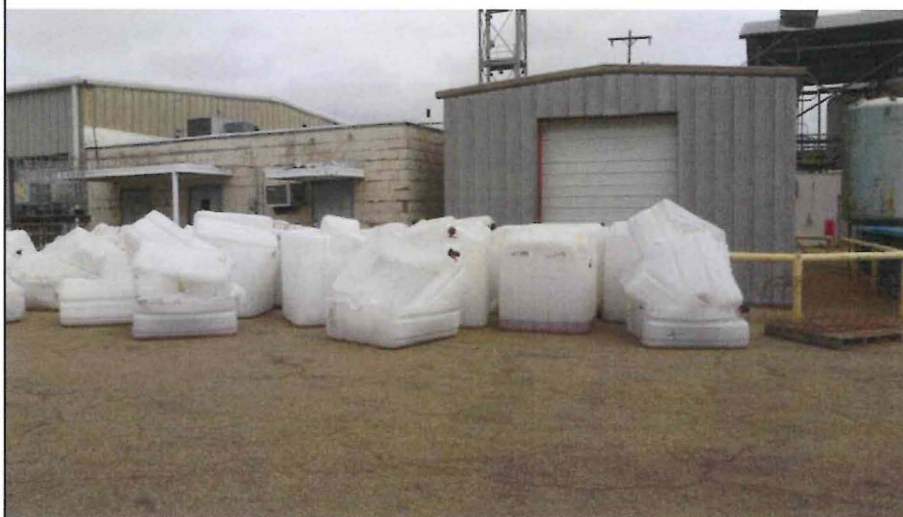
Photographer:		A. Cusher			Witness:		J. Rigg	
Photo #	6	Of	6		Date:	4/27/2012	Time:	
Description:		Damaged empty containers
